# REAL ESTATE APPRAISAL REPORT

R. No: 2013REVB143

ESKİŞEHİR IBIS HOTEL, RESTAURANT AND FITNESS CENTER

TEPEBAŞI / ESKİŞEHİR

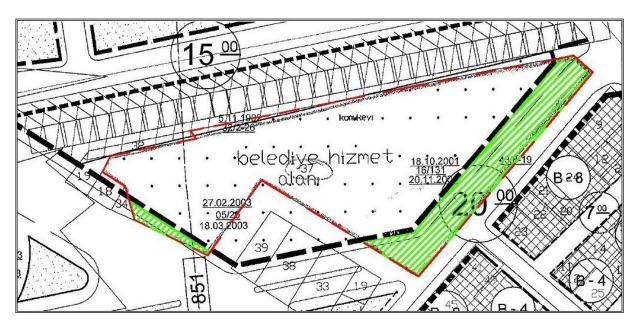
The immovable property remains in the legend "Municipal Service Area and Road" in the Application Zoning Plan in the scale of 1/1000 approved dated 18 October 2001.

The eminent domain for road of the land of the appraised property has been roughly marked in green on the above map.

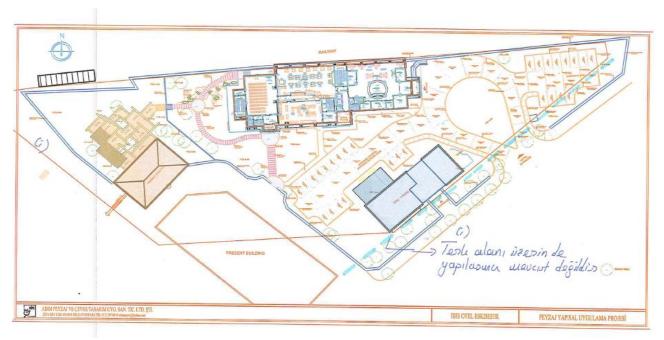
Nearly 1,322 sqm of the land is within the borders of eminent domain, and there are not any buildings on the eminent domain areas as also noted here above.
